Manhole Inspection Summary

Manhole # S15Y__011MH

Location Address: **1500 DESOTO RD**

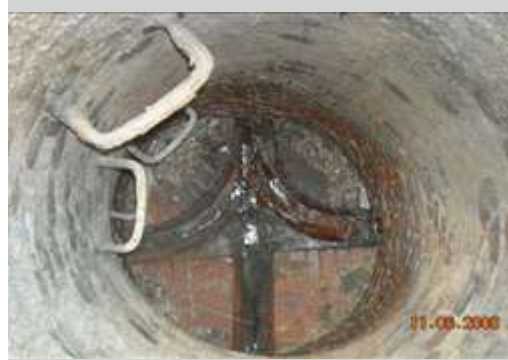
Top View

Comments **TRAFFIC CONTROL WAS REQUIRED TO COMPLETE INSPECTION. LOCKING LID WAS MISSING CENTER BOLT AND BAR.**
